The DSN Hydromechanical Service Program— A Second Look

R. Smith and O. Sumner
DSN Facility Operations Office

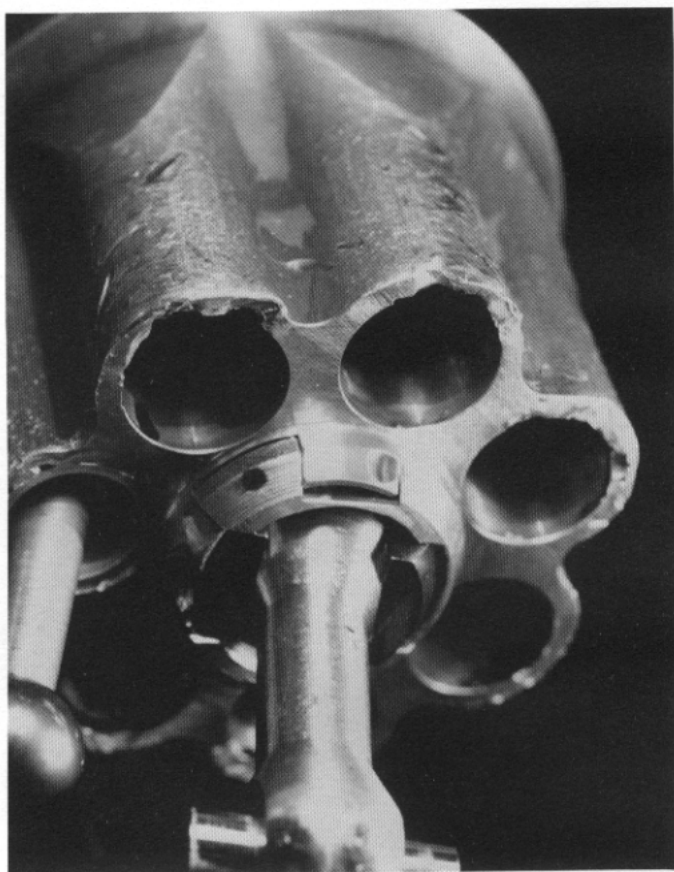
- (9) Figures 1 and 2 show the rotating group of a 64-m antenna drive motor removed from DSS 42 because of blown seals and a faulty crossfeed valve. Internal inspection revealed that a complete separation of the rotating group had occurred, resulting in severe damage to the cylinder block, seizure of one piston in the block, and separation of the piston from the shoe. A new rotating group was installed, and the motor was tested for smooth operation and static tested prior to being returned to the station.

Fig. 1. 64-m antenna drive motor cylinder block

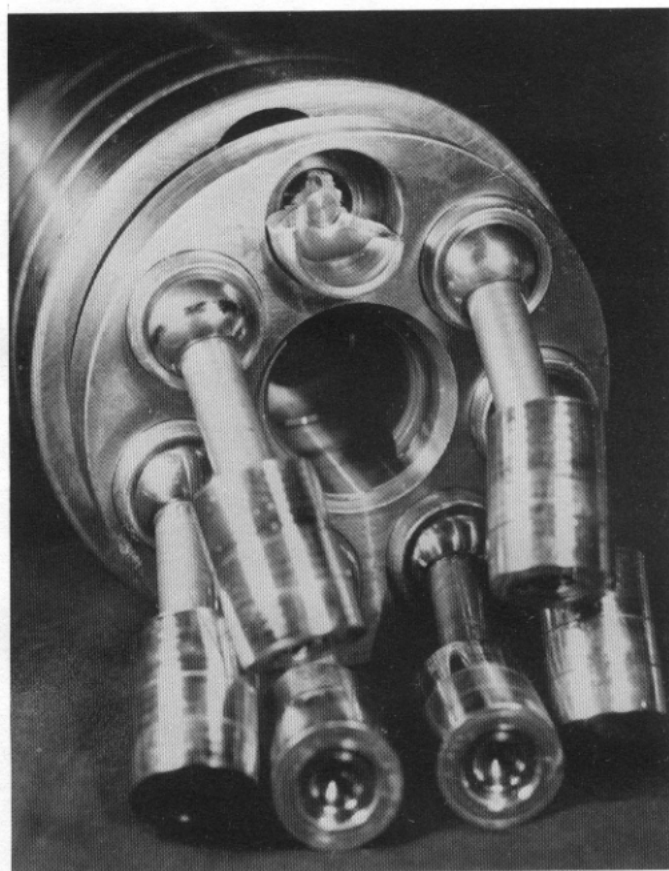
Fig. 2. 64-m antenna drive motor shaft and piston assembly
(Note separation of piston from bronze shoe.)
